Manhole Inspection Summary

Manhole # S25I__053MH

Insp Date: **3/17/08 10:56 AM**

Location Address: **1301 LEMMON ST.**

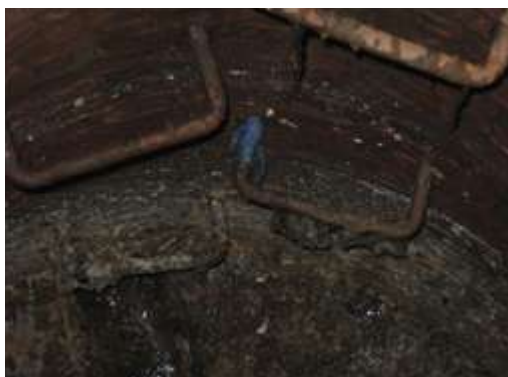
Defect 1

Count: **5** Missing: **0** ☒ **Corroded**

Corroded steps

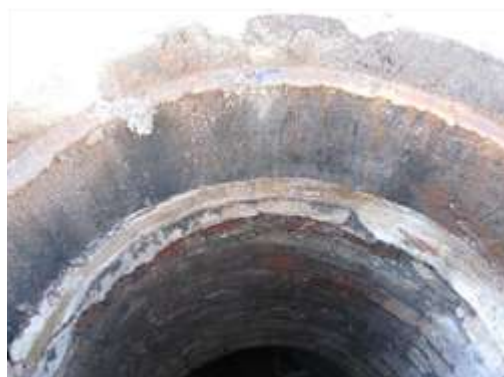
Defect 2

Condition: ☐ Sound ☐ Cracked ☒ **Leaks**

Lid -frame infiltration

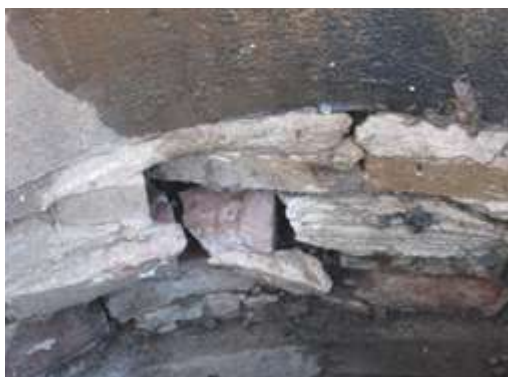
Defect 4

Condition: ☐ Sound ☒ **Cracked** ☐ Root Intrusion ☒ **Loose Brick** ☒ **Deteriorated**

Infiltration: ☐ None ☐ Joint ☒ **Cracks** ☒ **Mortar** ☐ Roots ☐ Wall

MISSING MORTAR AND CRACKED BRICKS WITH EVIDENCE OF INFILTRATION AT THE CHIMNEY

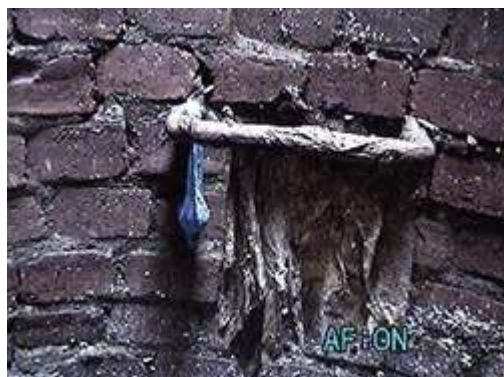
Defect 5

☒ **Evidence Of Surcharge** Depth: **3** (ft.) ☐ Active Surcharge Present

EVIDENCE OF SURCHARGE ON STEP

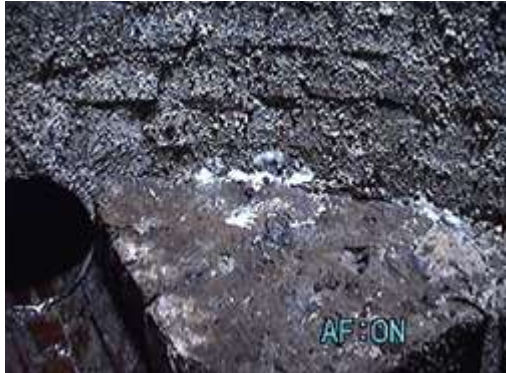
Defect 3

Condition: ☐ Sound ☐ Cracked ☐ Root Intrusion ☐ Loose Brick ☒ **Deteriorated**

Condition: ☐ Sound ☐ Cracked ☐ Root Intrusion ☒ **Deteriorated** ☐ Leaks ☒ **Debris**

DETERIORATED BARREL WITH
DEBRIS ON BENCH

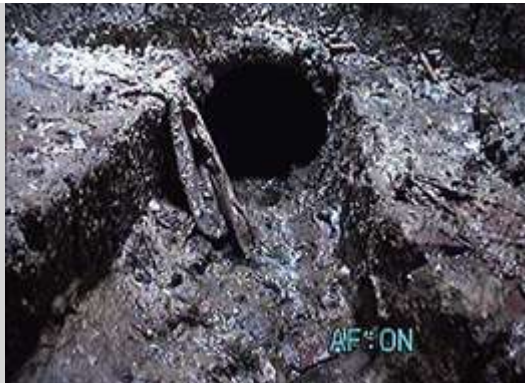
9 O'Clock Inflow

Deposits: ☐ None ☐ Mud ☒ ~~Sludge~~ ☐ Debris ☐ Grease

Silt Depth: **0.25** (in.) Deposits Extent: **Light**
